# Climate Change Impacts on Water and Wastewater Infrastructure at Akwesasne

## Final Report

Ontario First Nations  
Technical Services Corporation  
(OFNTSC)

June 21, 2017

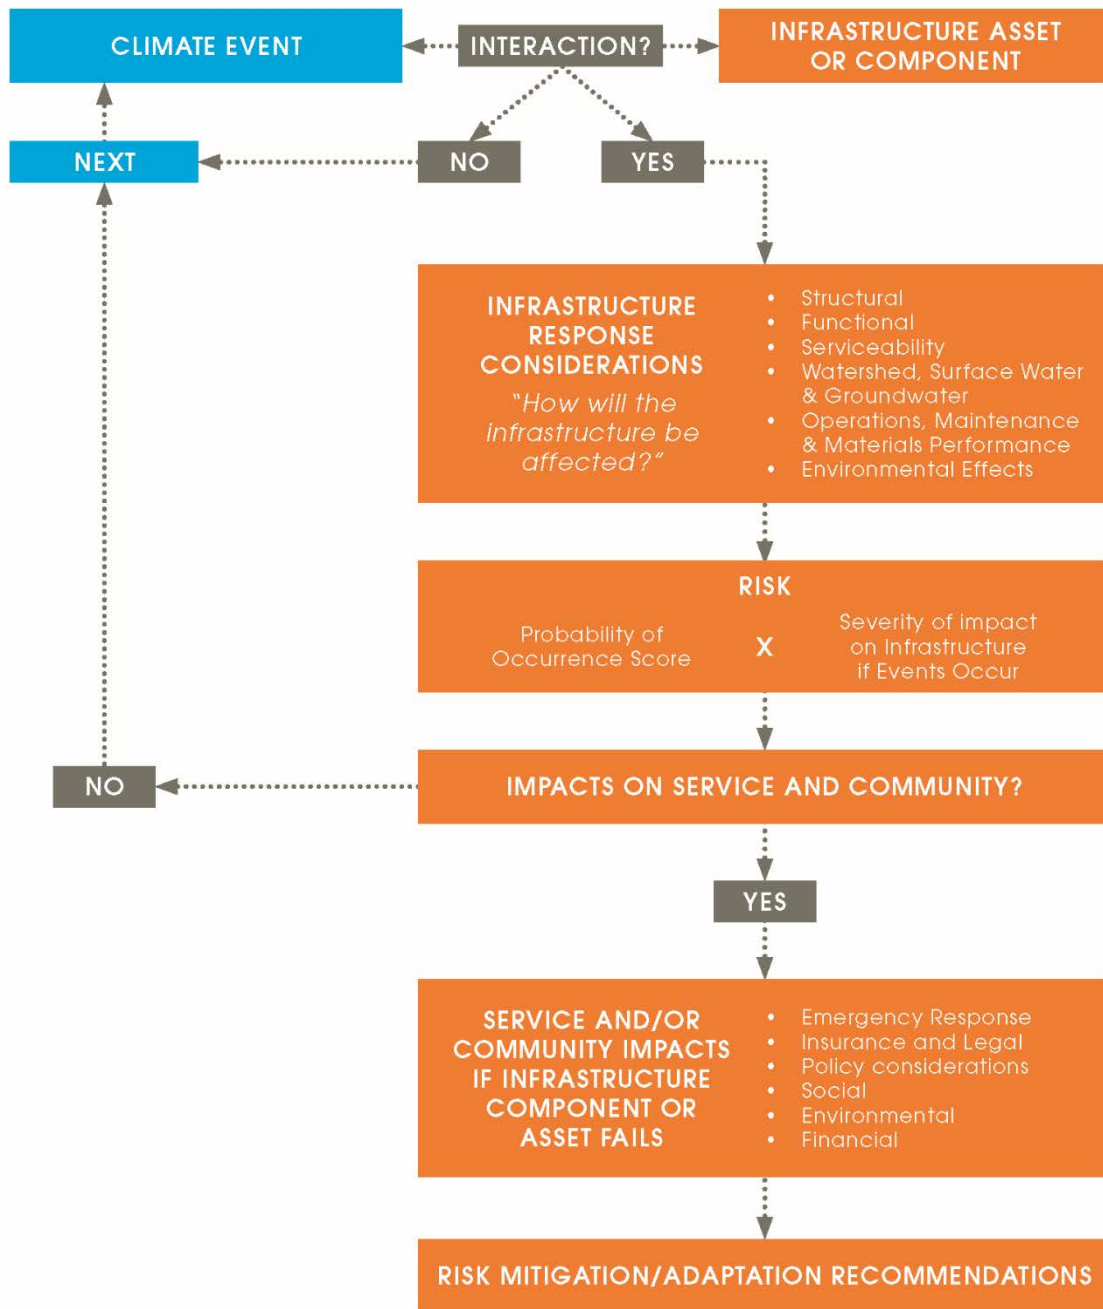
Figure 1: Process used to establish infrastructure risks and impacts on the community

As the Project Team progressed through the project, it became evident that there were two types of impacts for the climate events: 1) impacts on the performance of the infrastructure itself, and, 2) impacts on the service to the community should the infrastructure fail to deliver as designed. It was therefore decided to establish the risks with respect to the infrastructure assets considering the infrastructure response factors, followed by the consequences on the service and/or the community should the risk materialize and the infrastructure fail to perform. This process is illustrated in Figure 1 next page.

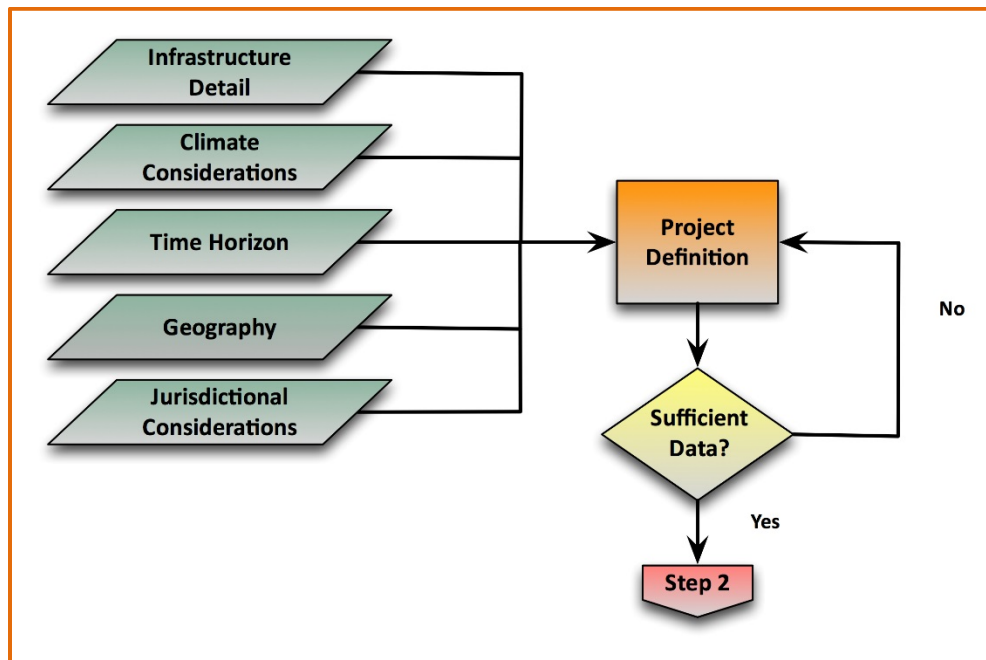
**Figure 3: PIEVC Protocol Project Step 1 - Definition Process Flowchart (Source: Engineers Canada, PIEVC Protocol Revision PG-10, May 2012)**

The PIEVC Protocol illustrates the elements that are considered during the Project Definition step as illustrated in **Figure 3** below.

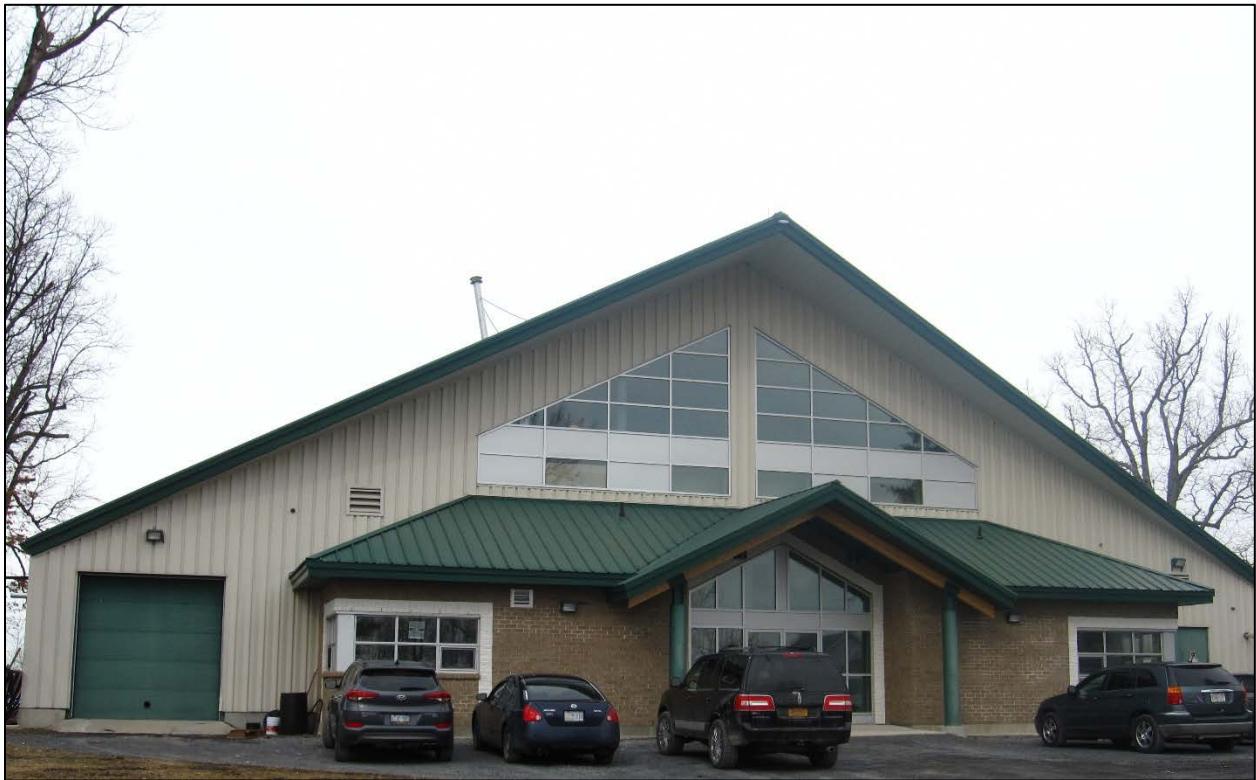
**Figure 7: Cornwall Island Water Treatment Plant Building**

Figure 7 below shows frontal photo of the building.

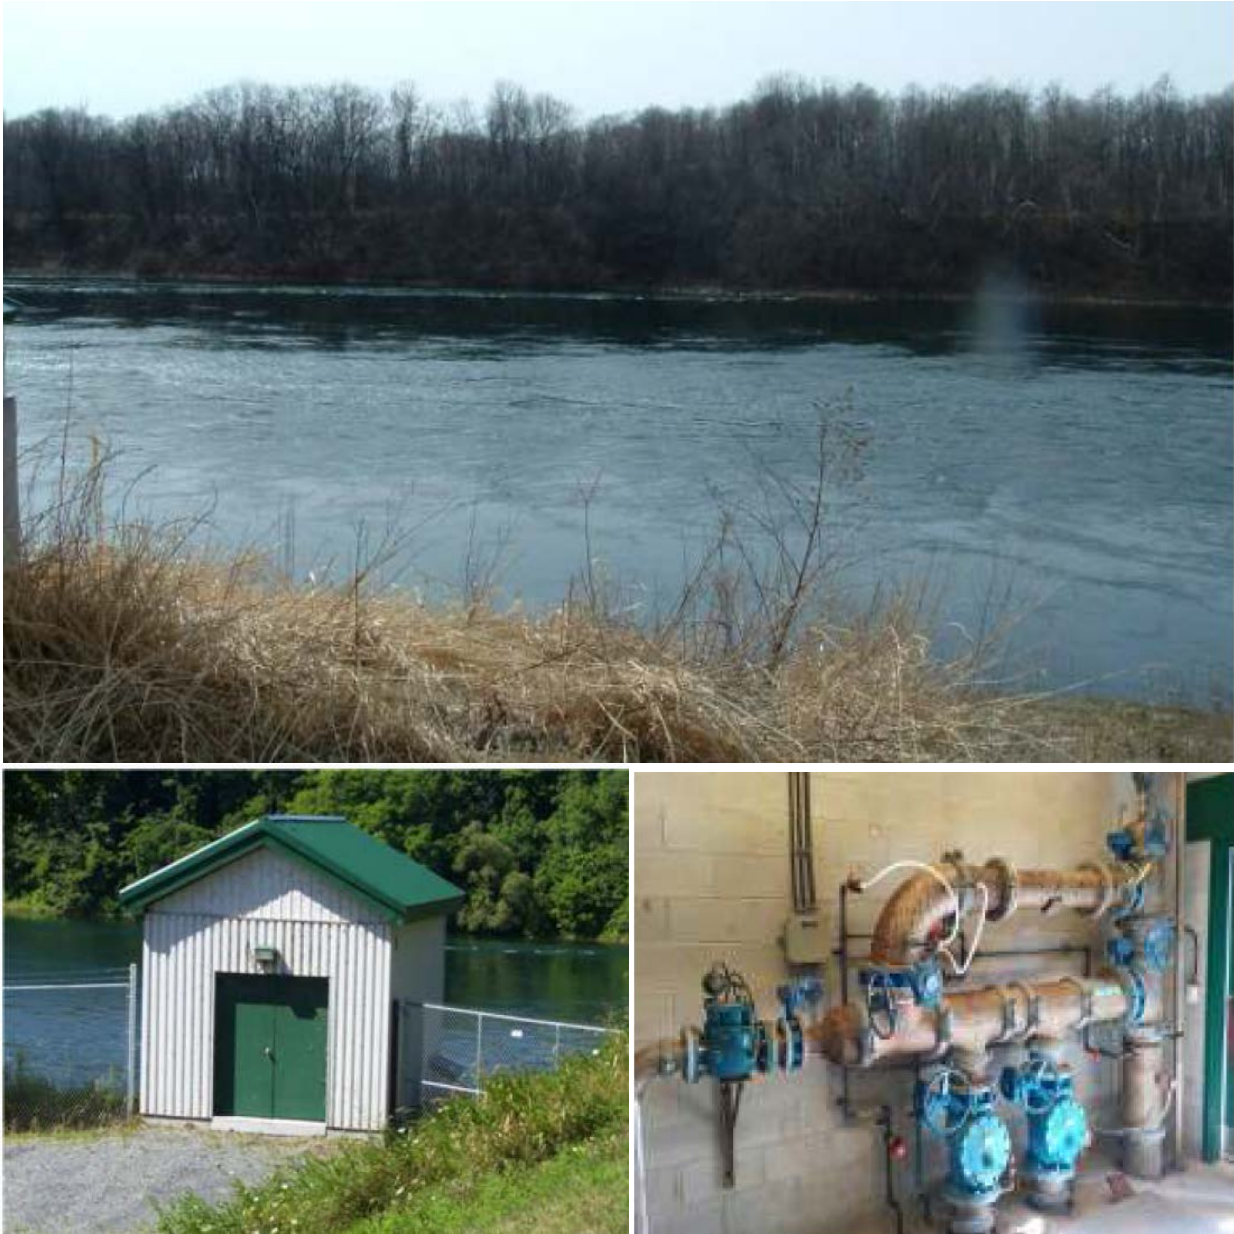
**Figure 8: Intake and Low Lift Pump**

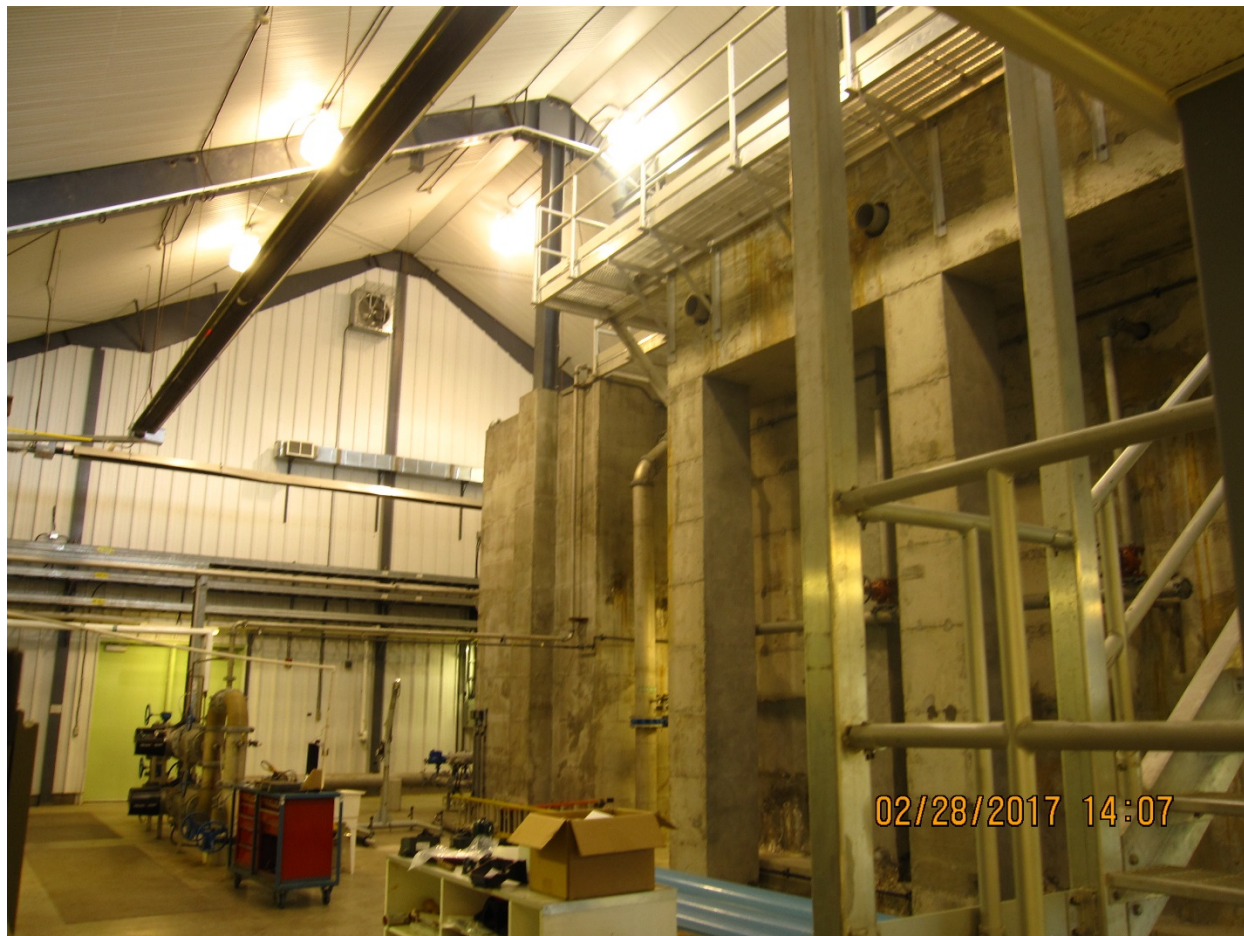
coagulation of particles to facilitate removal through the filtration system. Filtered water is captured and conveyed to the UV treatment system for disinfection.

**Figure 9: Inside View of the Cornwall Island WTP**

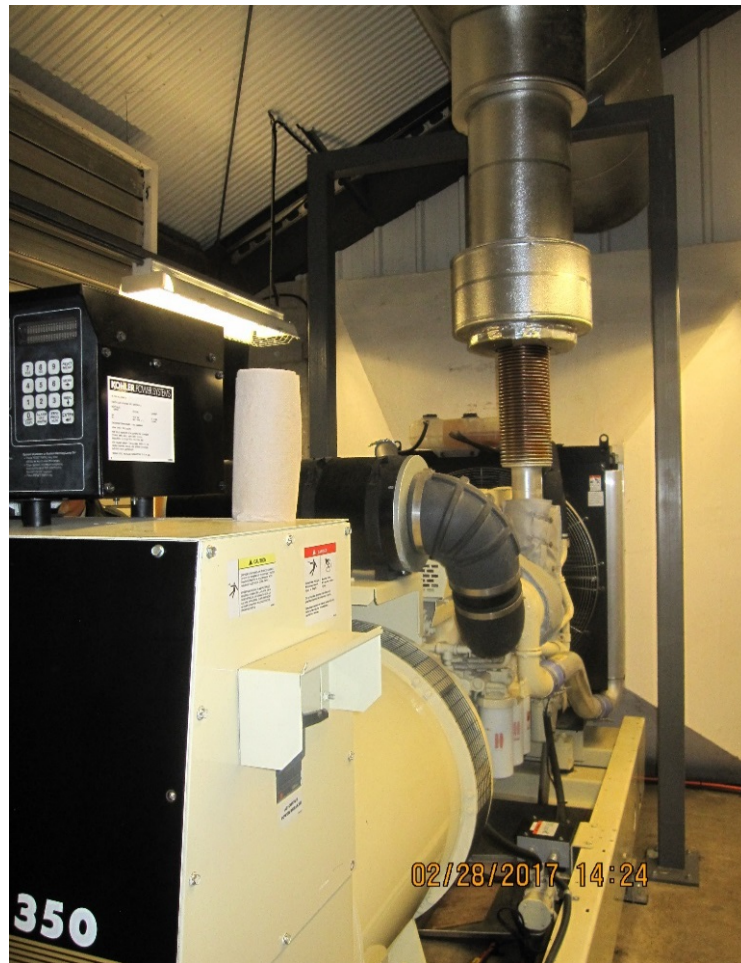
A diesel generator provides a back-up power source for the WTP. On-site fuel storage provides sufficient fuel to power the generator continuously for approximately 3 days. The generator is serviced and tested regularly to ensure it is maintained operable in the event of a power failure.

Figure 11: MCA Water Treatment Plant Backup Generator

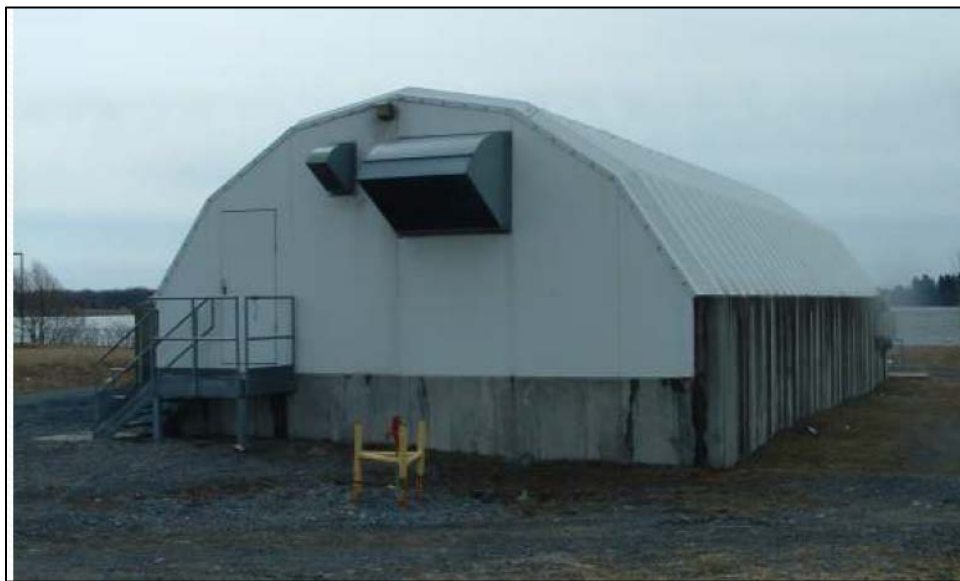
- Cornwall Island Block 97 RBC
  - o Built in 2001 to replace a smaller system
  - o Services all of Block 97
  - o Discharges by gravity to the St-Lawrence River on the shore of the island

Figure 12: Exterior View of Block 97 RBC

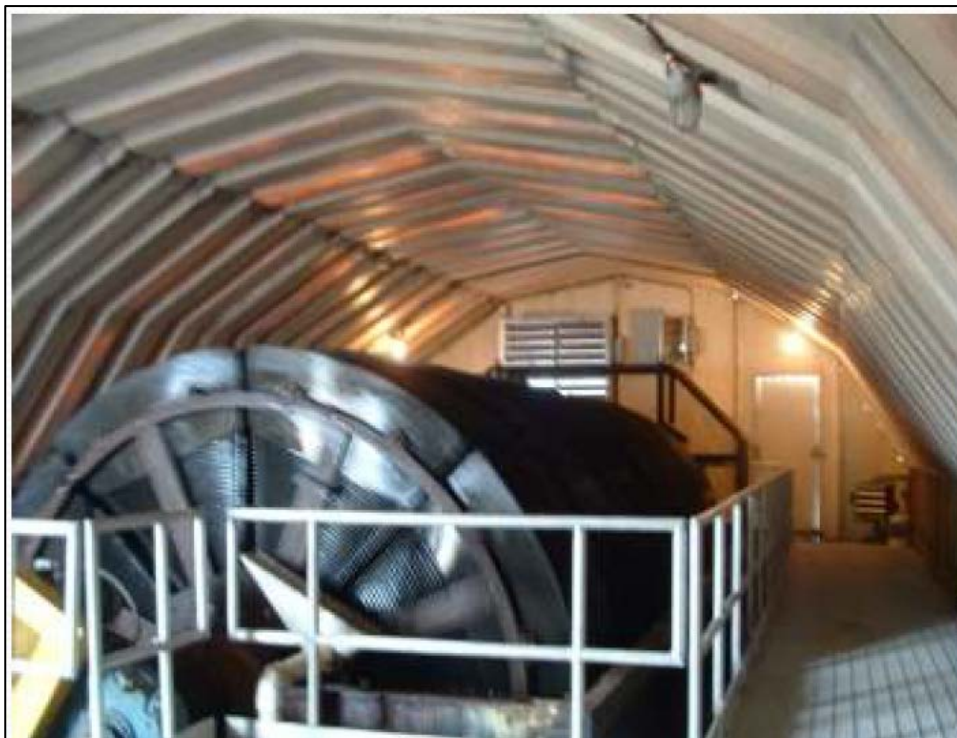
Figure 13: Interior View of Block 97 RBC

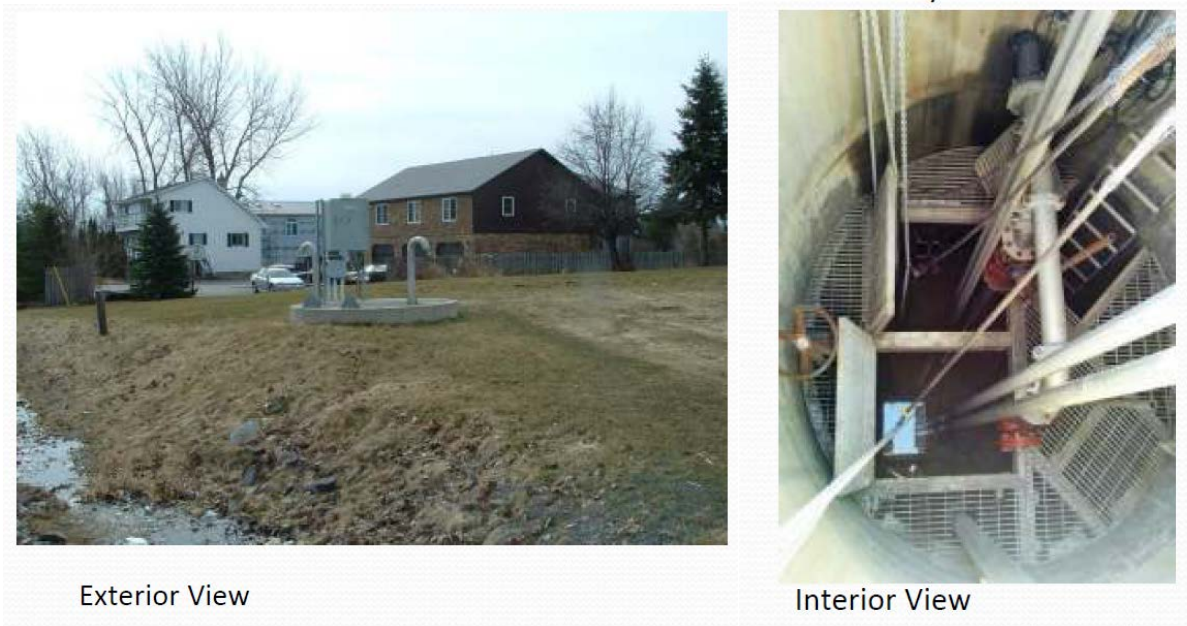
- Pumps wastewater from the CIA complex to the AMS RBC for treatment.
- Constructed in 2002

Figure 14: Exterior and Interior Views of the Cornwall Island Administration Pump Station

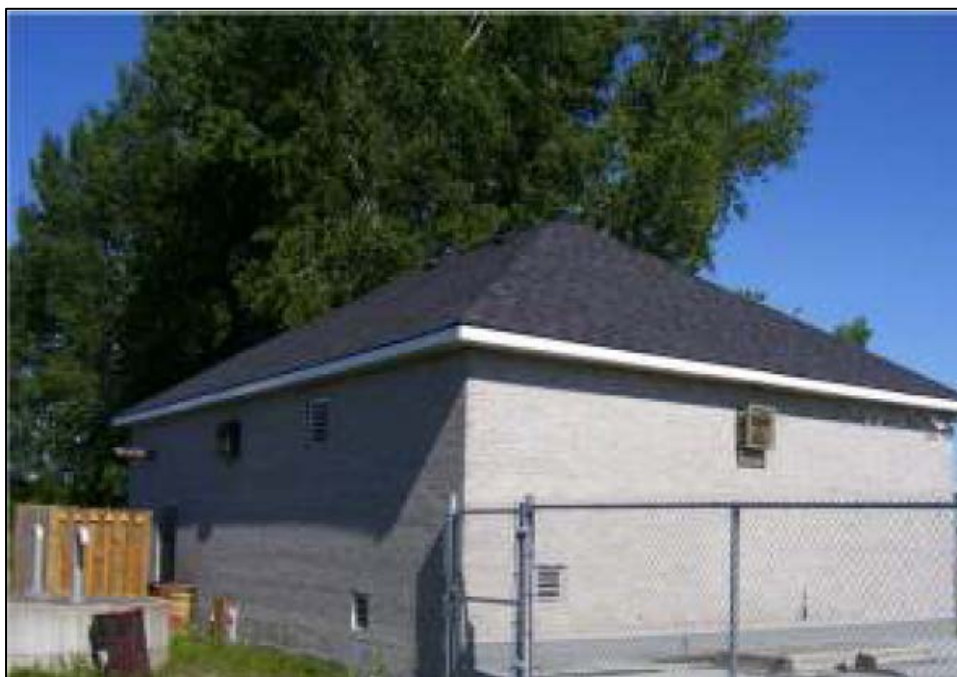
A high-lift water pumping station is also operational at the Block 97 site; this lift station was initially constructed in 1989 to service the development but is now on standby since the construction of the water treatment plant.

Figure 15: Building of the High Lift Station at Block 97

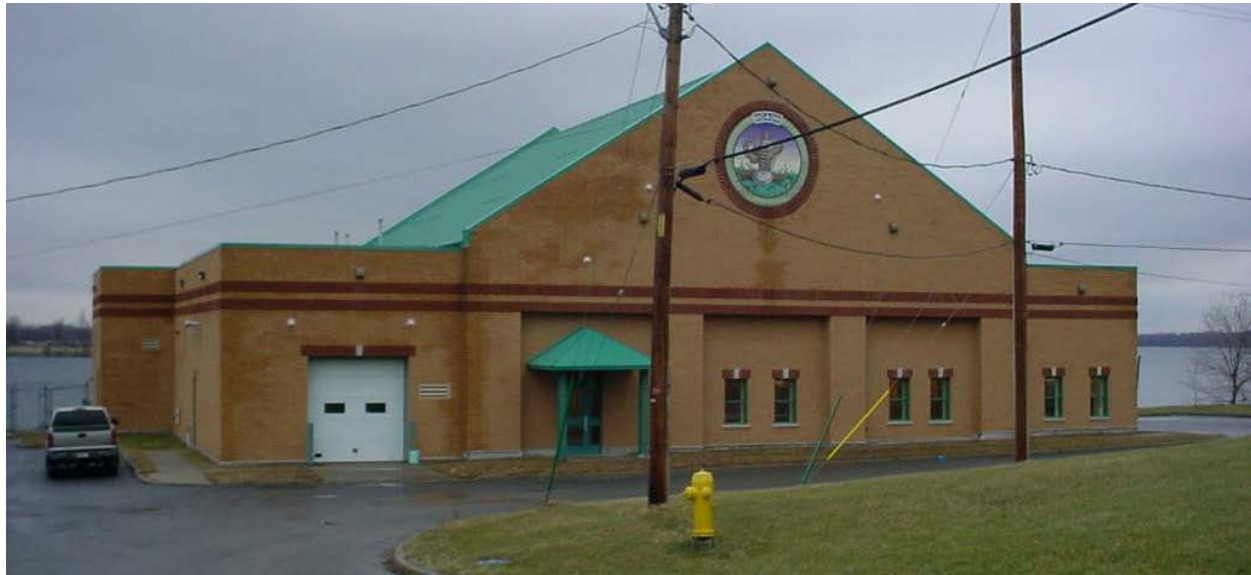
The St. Regis WTP uses direct filtration treatment to provide potable water to all of St. Regis and a portion of Snye’s water distribution system. The facility is located on the on the south bank of the St-Lawrence River. The facility was constructed in 1998 and designed for a population projection of 2,500 persons. The facility is designed with a total flow capacity of 2046m<sup>3</sup>/d and serves to meet average day demand flows of 300Lcpd. The WTP has a total storage capacity of 1,639m<sup>3</sup> within the reservoir which includes a fire flow reserve of 842m<sup>3</sup>.

Figure 17: Exterior View of the St. Regis Water Treatment Plant

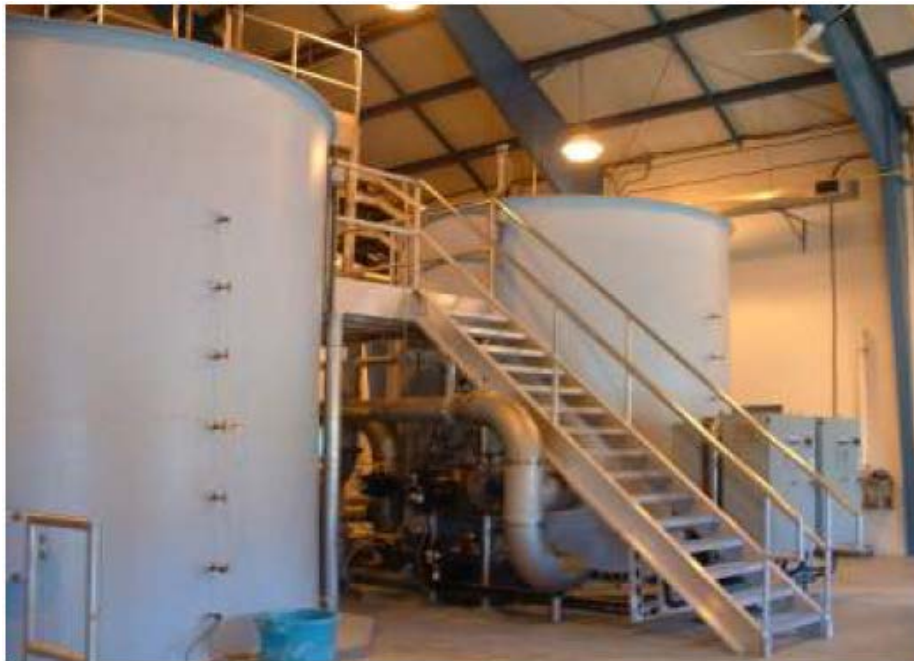
The treatment facility draws raw water from an intake of the shore of the St-Lawrence River. Treatment of the raw water is achieved using granular activated carbon (GAC) filters and ultraviolet (UV) system disinfection.

Figure 18: Granular Activated Carbon Tanks at St. Regis WTP

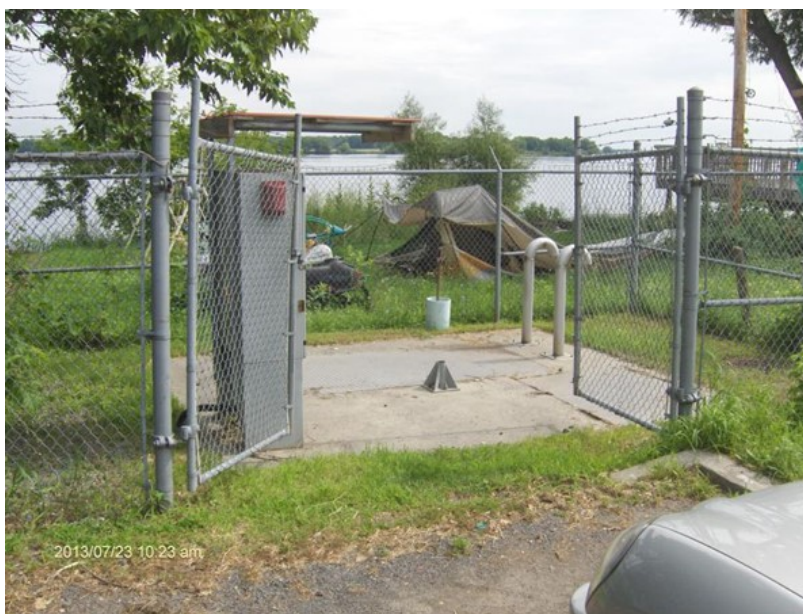
This lift station services the entire lower region of St. Regis Village which consists of approximately 150 homes. Constructed in 1998 the lift station is located near the north central limit of the village.

**Figure 19: Exterior of the Cherry Street Pump Station**

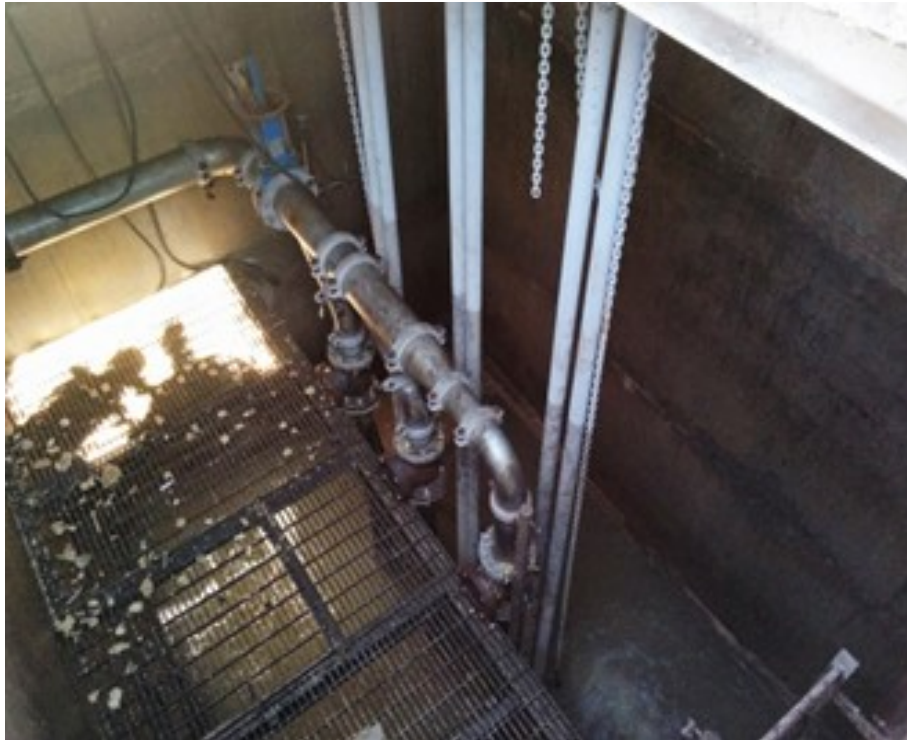
**Figure 20: Interior of the Cherry Street Pump Station**

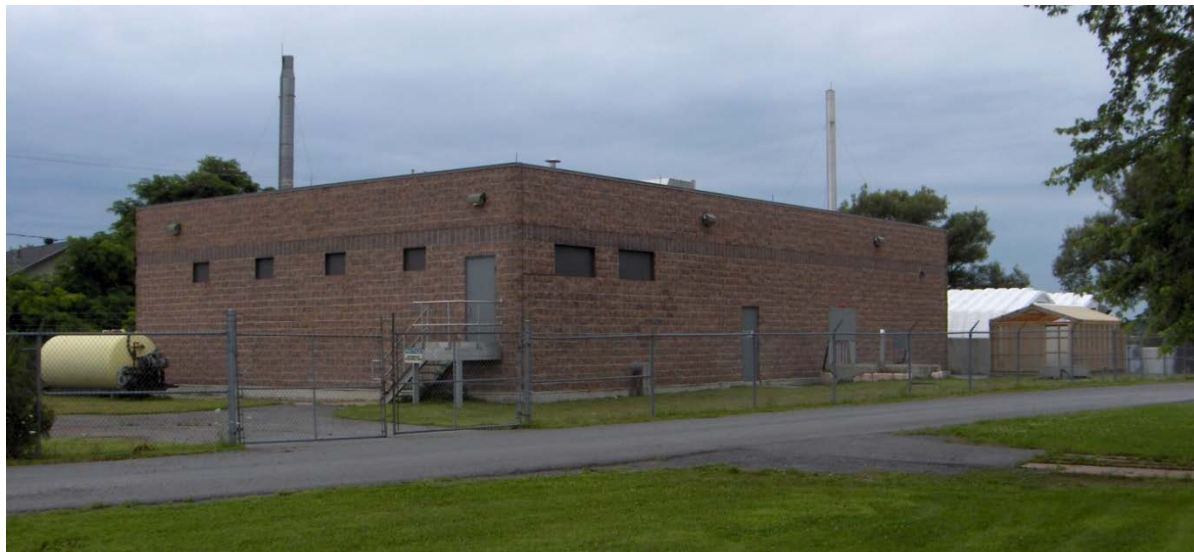
The St. Regis waste water treatment plant (WWTP) was constructed in 1991 and services the entire village of St. Regis. While the facility was originally constructed in 1991 the existing treatment system relies on Geoform RBC units installed in 2001. The facility has a design capacity for 2018 population projections of 2,000 persons and uses and has a rated capacity of 1,080m<sup>3</sup>/d. The plant's peak hydraulic capacity is 42.7L/s for three hours.

**Figure 21: Exterior View of the St. Regis Wastewater Treatment Plant**

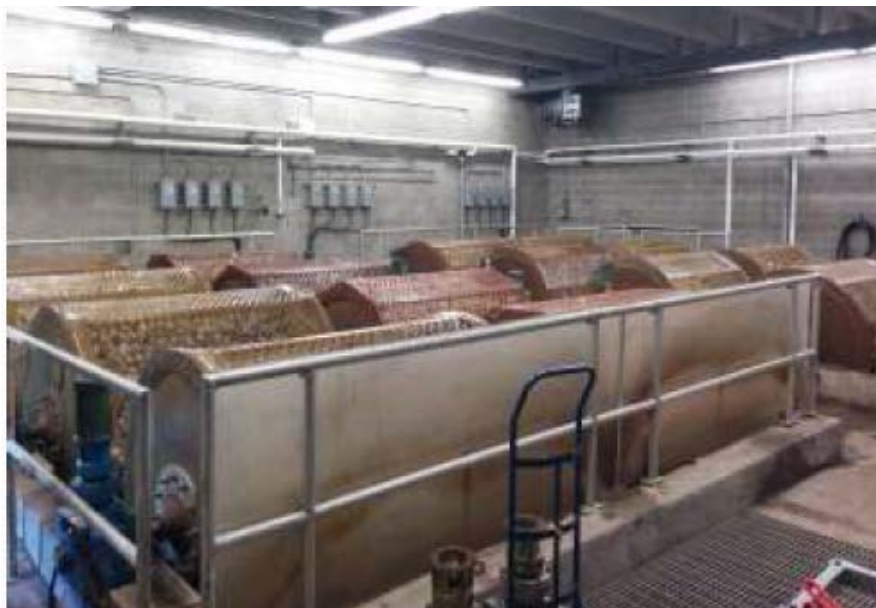
The treatment facility provides primary and secondary treatment of wastewater. Primary treatment is achieved through settling of solids while secondary treatment is achieved through the four train RBC system composed of four trains of four units. Treated wastewater is pumped from the PS3 lift station for discharge to the St-Lawrence River. The pump station is located underground with a control panel located at the surface. The lift station was constructed in 1999.

**Figure 22: RBC Units at St. Regis WWTP**

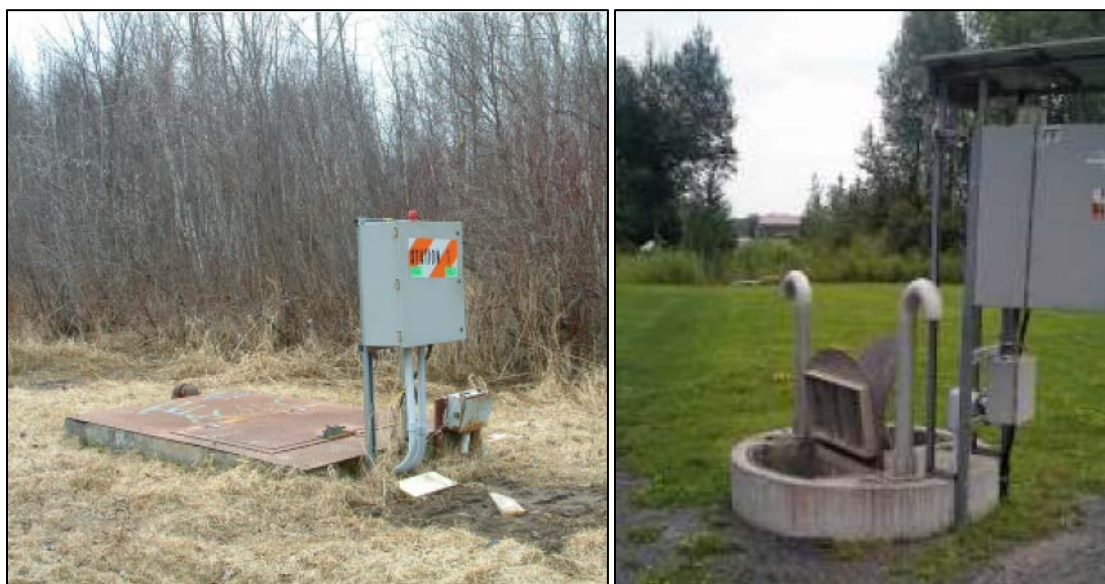
Pump station 2 was constructed in 2009 and services the residential subdivision along CH-704 and Sweet Grass Lodge Road. The facility is located below ground with a control panel at the surface.

Figure 24: Snye Pump Station #1 (left) and Pump Station #2 (right)
